**DEPARTMENT OF TRANSPORTATION**

Contract #: 04-0120F4Cty: SF/ALA Rte: 80 PM: 13.2/13.9File #: 1.28**WELDING INSPECTION REPORT****Resident Engineer:** Casey, William**Address:** 333 Burma Road**City:** Oakland, CA 94607**Report No:** WIR-027270**Date Inspected:** 24-Feb-2012**Project Name:** SAS Superstructure**OSM Arrival Time:** 700**Prime Contractor:** American Bridge/Fluor Enterprises, a JV**OSM Departure Time:** 1530**Contractor:** American Bridge/Fluor Enterprises, a JV**Location:** Job Site**CWI Name:** Salvador Merino**CWI Present:** Yes No**Inspected CWI report:** Yes No N/A**Rod Oven in Use:** Yes No N/A**Electrode to specification:** Yes No N/A**Weld Procedures Followed:** Yes No N/A**Qualified Welders:** Yes No N/A**Verified Joint Fit-up:** Yes No N/A**Approved Drawings:** Yes No N/A**Approved WPS:** Yes No N/A**Delayed / Cancelled:** Yes No N/A**Bridge No:** 34-0006**Component:** OBG**Summary of Items Observed:**

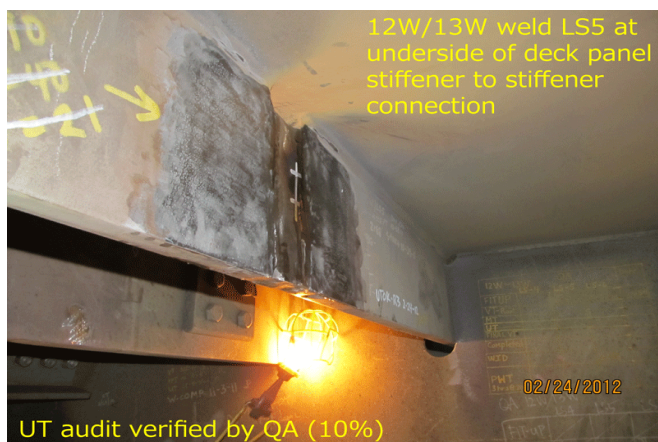
This QA performed Ultrasonic Testing (UT) on approximately 10% of welds at the following location and weld numbers: 12W/13W LS5.

This QA observed no rejectable indications at the time of testing. This QA generated a TL-6027 UT report on this date. The completed work observed at this location appeared to be in compliance with the contract specifications.
